Device Errata

Skywire® Raspberry Pi Adapter

NimbeLink Corp

Updated: July 2017

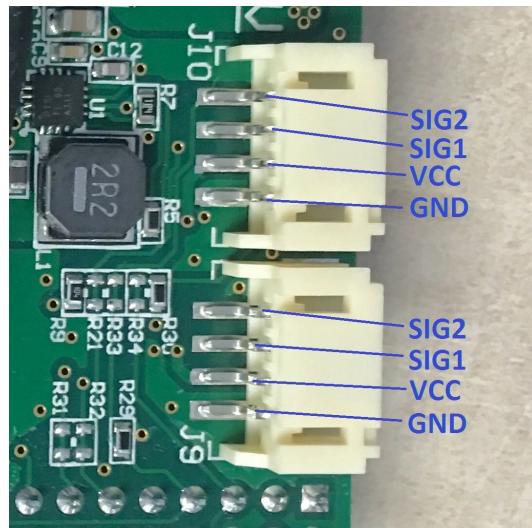
Applications using the Grove connectors on NL-AB-RPI adapter board with PCB revision 1001430 REV A are affected. The grove connector pins are reversed, as shown in the image below. Users who wish to use Grove sensors on affected PCBs must follow the steps outlined in section four of this errata.

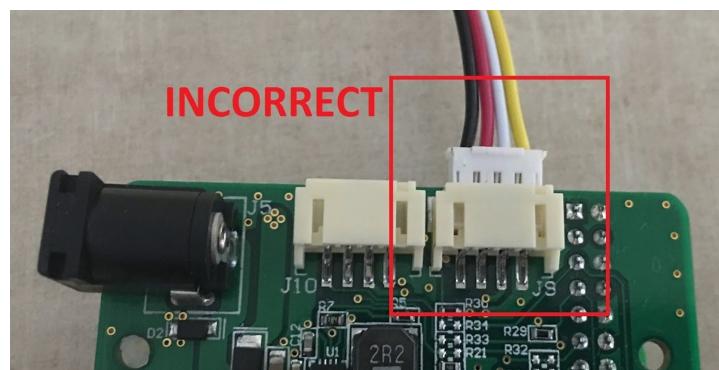
Grove sensors using unmodified cables should not be directly attached to the Grove connectors on affected boards as this may cause shorts and/or damage to the sensor or Raspberry Pi.

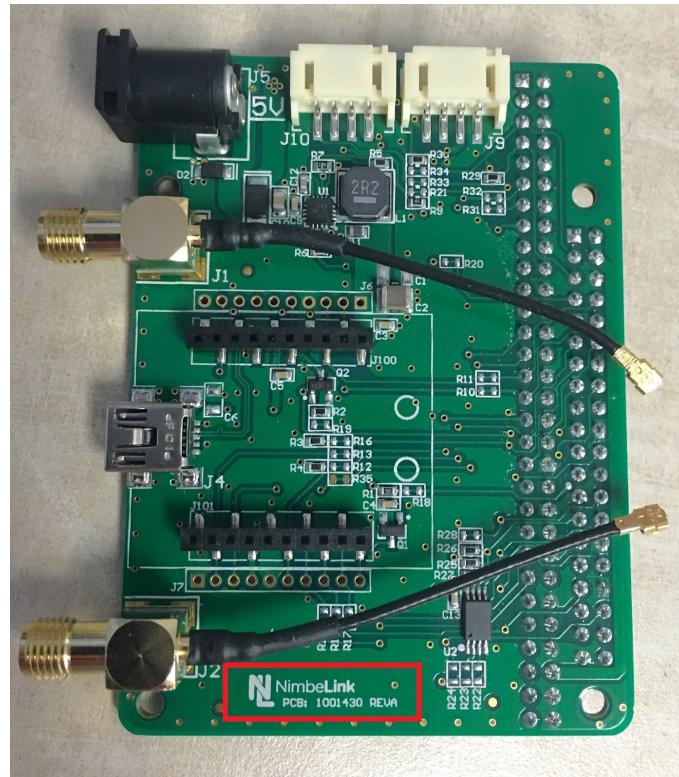
The PCB revision number is located on the bottom of the top side of the PCB. This Errata affects all NL-AB-RPI boards with a PCB revision number of 1001430 Rev A.
