LAN9646 Silicon Errata and Data Sheet Clarification

This document describes known silicon errata for functional revisions A1 of the LAN9646. The silicon errata discussed in this document are for silicon revisions as listed in [Table 1](#). The silicon revision can be determined by the device's top marking. A summary of LAN9646 silicon errata is provided in [Table 2](#).

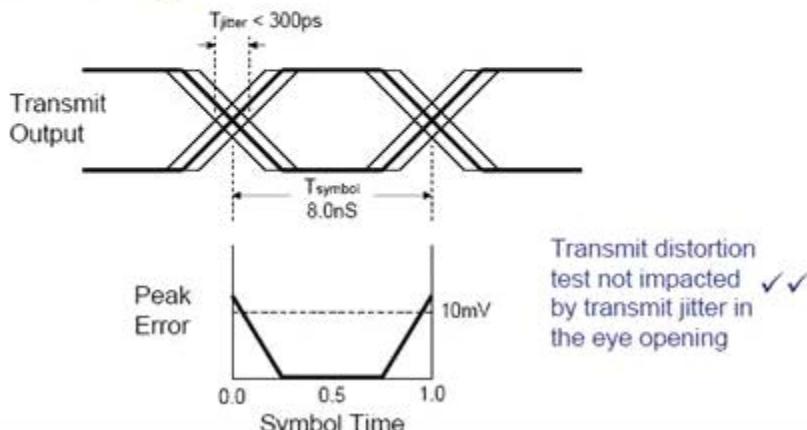
FIGURE 1: IEEE DOCUMENT PAGE 6

The device's 1000BASE-T Transmitter Distortion is approximately 40mV, versus the <10mV indicated in the IEEE specification.

IEEE testing calls for <10mV peak transmitter distortion for at least 60% of the UI within the eye opening. However, this measurement might not be valid, as the transmit distortion test is sensitive to transmit jitter. Refer to the explanation below, taken from the aforementioned IEEE document.

Consistency Between Transmit Jitter and Transmit Distortion Specifications

- PHY operating with allowed transmit jitter will not be able to meet 10mV distortion spec *if the distortion spec must be met at the edges*

None.
