# Intel® Ethernet Controller I210

## Specification Update

Revision 2.8  
332763-012

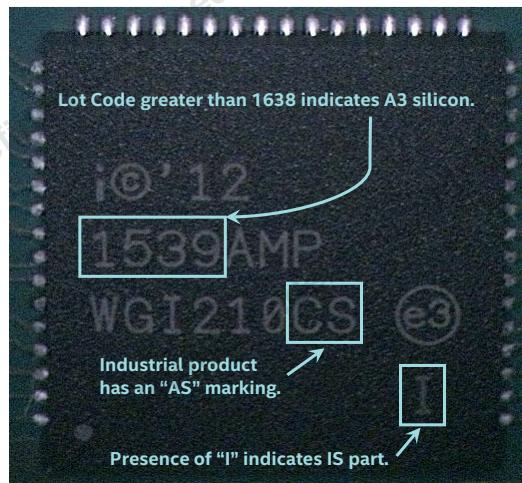
Figure 1-1. Explanation of Top Markings for A3 Stepping

- Fab Lot Trace Codes starting with 1638 or greater are A3 devices.
- Bit 1 of INVM\_DATA[61] (0x12214) is 1b on A3 devices.

Figure 1-1 shows an example:
