APPLICATION NOTE

AN60301

Using the Gopher Wifi module on
the RK3399-Q7 Devkit

Document revision: Release v1.1
Issue date: Jan 31, 2018

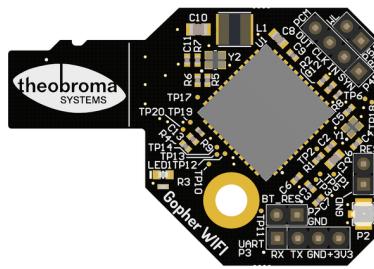
The Gopher WiFi module is a high-performance WiFi adapter based on the Broadcom BCM43455. Featuring an SDIO interface and a MicroSD connector, it can be used in the MicroSD slot on a RK3399-Q7 development kit.
