# Chip Errata for the i.MX 6ULL

This document details the silicon errata known at the time of publication for the i.MX 6ULL multimedia applications processors.

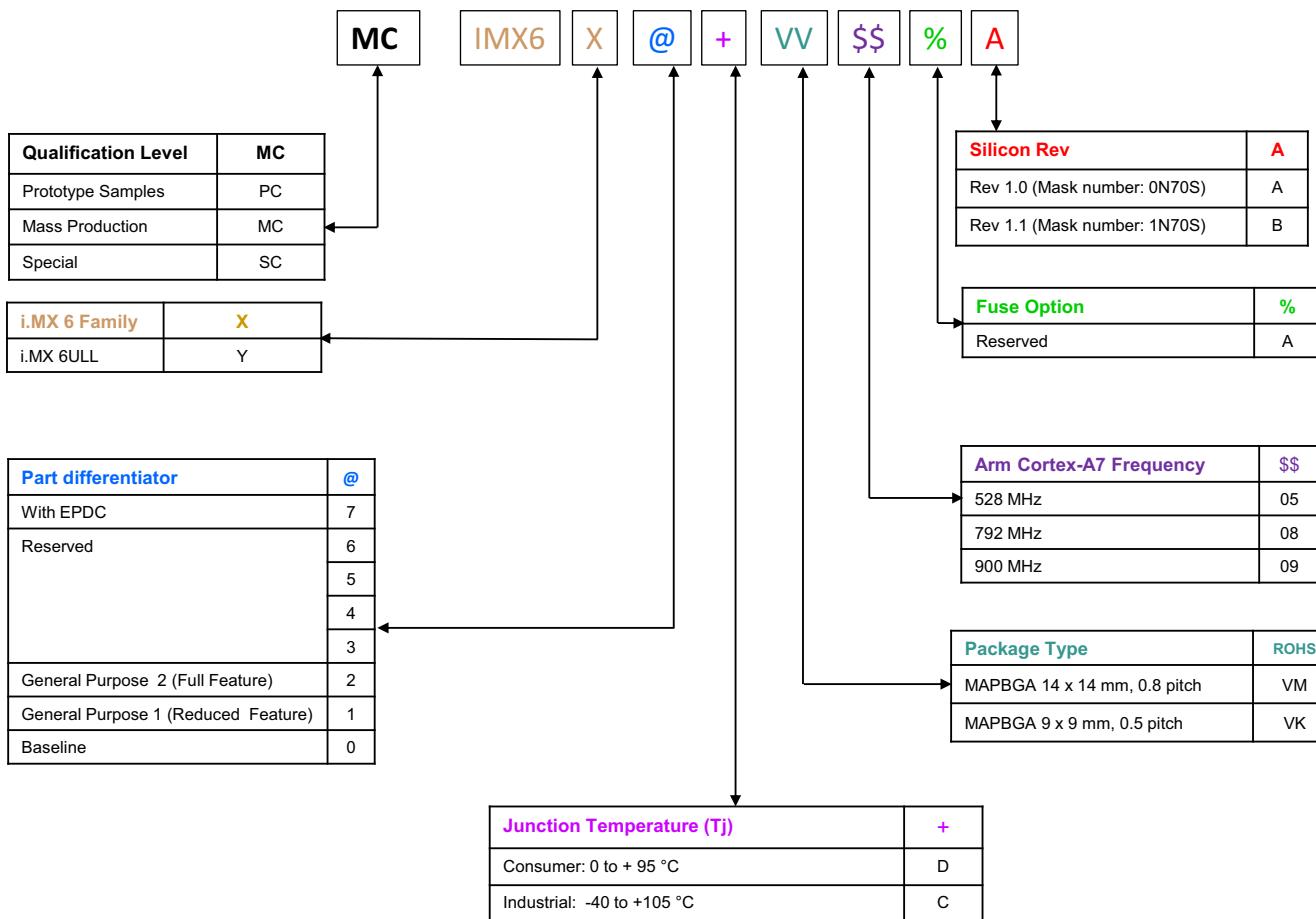
**Figure 1. Revision Level to Part Marking Cross-Reference**

Figure 1 provides a cross-reference to match the revision code to the revision level marked on the device.

Rev. Number	Date	Substantive Changes
Rev. 1.2	09/2017	<ul style="list-style-type: none"><li>Updated the silicon revision number in the <a href="#">Figure 1, "Revision Level to Part Marking Cross-Reference"</a></li><li>Added a new erratum:<ul style="list-style-type: none"><li><a href="#">ERR011121</a></li></ul></li></ul>
Rev. 1.1	05/2017	<ul style="list-style-type: none"><li>Updated the following Errata BSP status:<ul style="list-style-type: none"><li><a href="#">ERR007265</a></li><li><a href="#">ERR005778</a></li></ul></li></ul>
Rev. 1	03/2017	<ul style="list-style-type: none"><li>Changed the document title to "Chip Errata"</li><li>Updated the <a href="#">Figure 1, "Revision Level to Part Marking Cross-Reference"</a></li><li>Updated the following Errata BSP status:<ul style="list-style-type: none"><li><a href="#">ERR007265</a></li><li><a href="#">ERR005778</a></li><li><a href="#">ERR004446</a></li><li><a href="#">ERR007805</a></li></ul></li><li>Added new errata:<ul style="list-style-type: none"><li><a href="#">ERR010661</a></li><li><a href="#">ERR004535</a></li></ul></li></ul>
