N-series Intel® Pentium® Processors and Intel® Celeron® Processors

Specification Update

April 2015

Revision 001

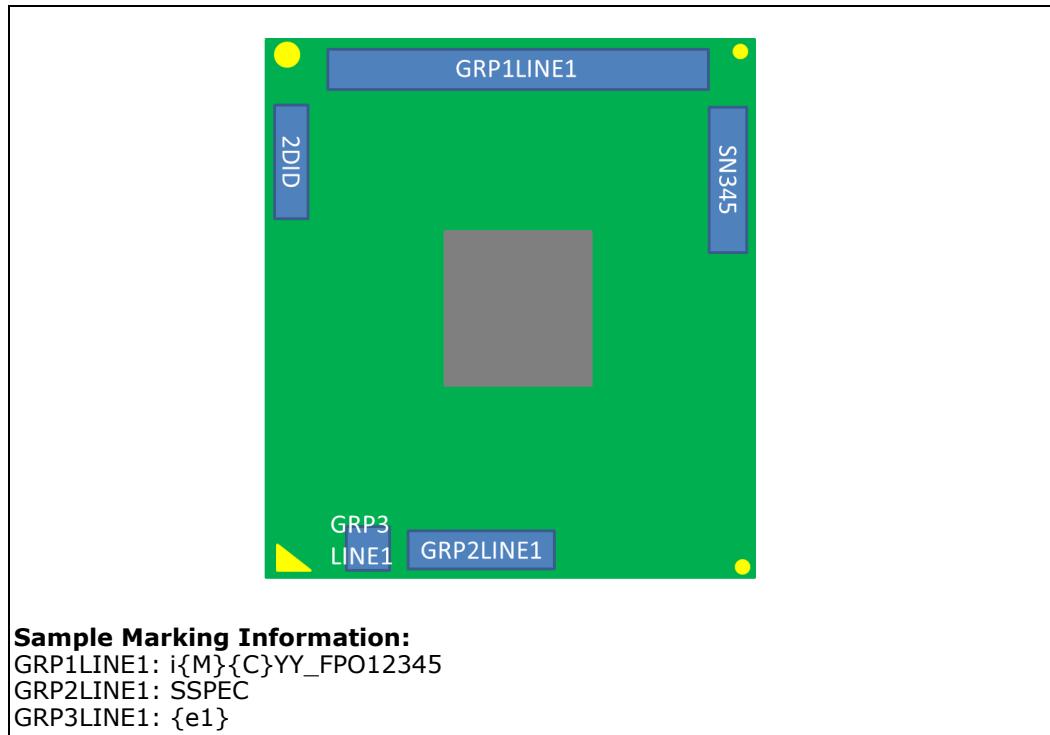
Figure 1. Processor Family Top-Side Markings

The processor stepping can be identified by the following component markings.
