## Test Report

Report No. A2250035365101002R2

Sample Name SMA Bulkhead Jack with O-ring, edge mount  
Model No. RFPC-SMA39-FN  
Sample Receiving State Normal  
Sample Received Date Jan. 15, 2025  
Testing Period Jan. 15, 2025-Feb. 5, 2025

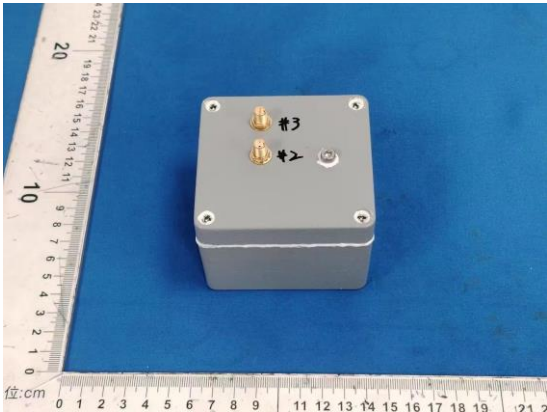
A2250035365101002

Sample Photo(s)

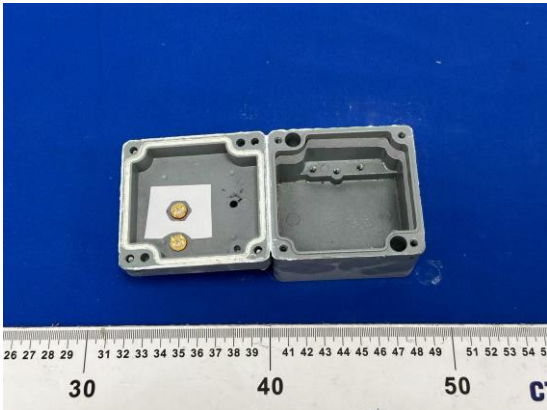
The lowest point of the sample is located 1000 mm below the surface of the water.

Test duration: 30min

| Sample No. | Criterion | Test result<br>( Visual inspection ) | Conclusion |
|---|---|---|---|
| A2250035365101002 | No water enters the sample | No water enters the sample | Pass |

Sample Photo(s) after the test

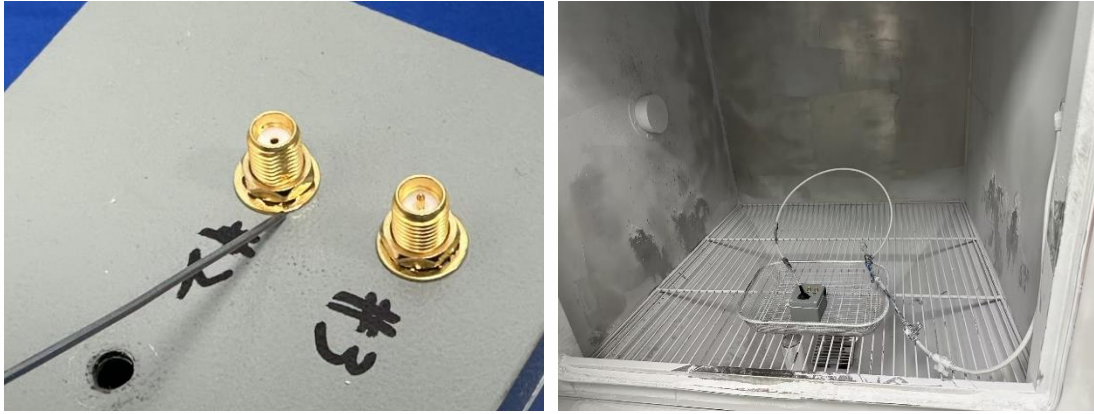
Use a test probe with a diameter of 1mm to probe the gap part of the sample with a force of 1N.

Put the sample in a negative pressure state, the pumping rate is 40~60 times the volume of the shell per hour, and the pressure difference between the pressure in the shell and the atmospheric pressure is less than 2kPa, and the test is continuously performed for 2h in the dust-proof test box.

## Test Photo(s)

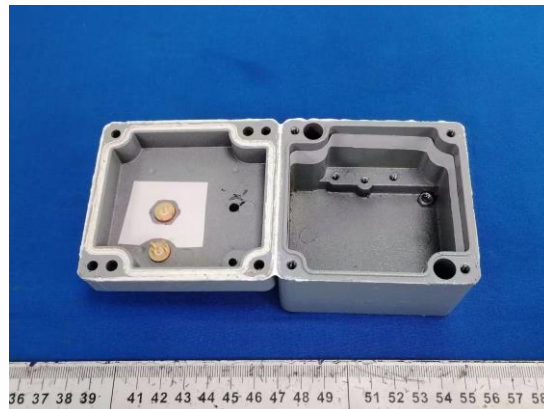
| Sample No. | Criterion | Test result<br>( Visual inspection ) | Conclusion |
|---|---|---|---|
| A2250035365101002 | The test probe cannot enter the inside of the sample, and the inside of the sample is dustless. | The test probe cannot enter the inside of the sample, and the inside of the sample is dustless. | Pass |

## Sample Photo(s) after the test
